Queens Transformer Fire Prompts Use of New Technologies

Foam Operations at Queens Box 33-6334

F-500 and its Use at Queens Box 33-6334

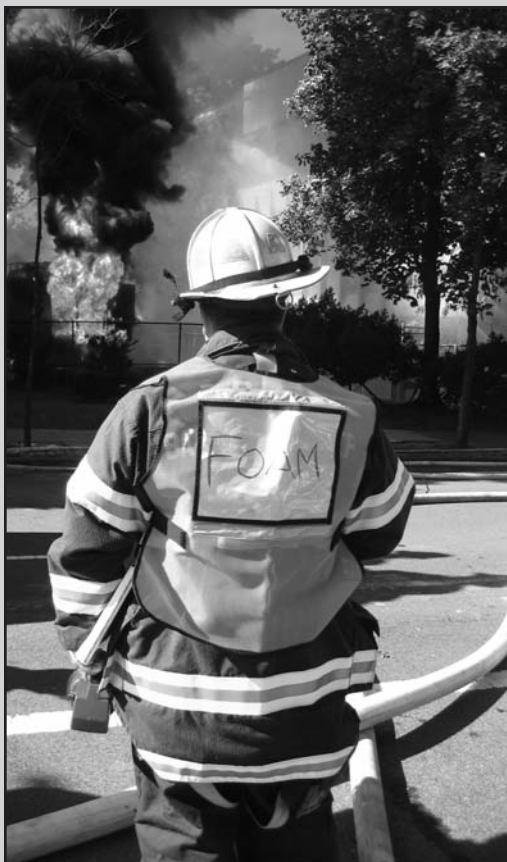
Transformer fire at Queens Box 33-6334, Northern Boulevard/45-08 244th Street, July 24, 2009.

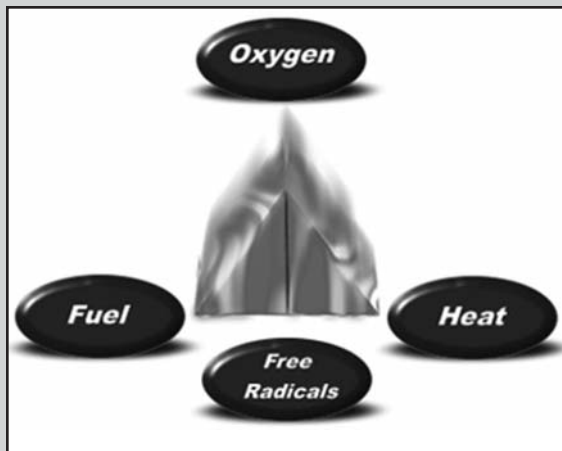
The burning material and surrounding non-combustible materials are cooled below the auto-ignition temperature of the burning material. F-500 acts on individual legs of the fire tetrahedron (see graphic at left) simultaneously. Foam separates the fuel from oxygen by forming a foam blanket. Foam is ineffective on flowing fuel and multi-dimensional fires.

When applied at the proper ratio, F-500 separates the fuel and oxygen by encapsulating the fuel in a chemical cocoon at the molecular level. The encapsulated fuel is neutralized and will not re-ignite even if disturbed. When F-500 was applied at this transformer fire, the fuel and transformer unit and internal oil were cooled. The flowing oil was cooled and neutralized; subsequently, the fire was quickly brought under control.
