Crane Calamity in Midtown Manhattan

Shoring Operations at 261 Madison Avenue

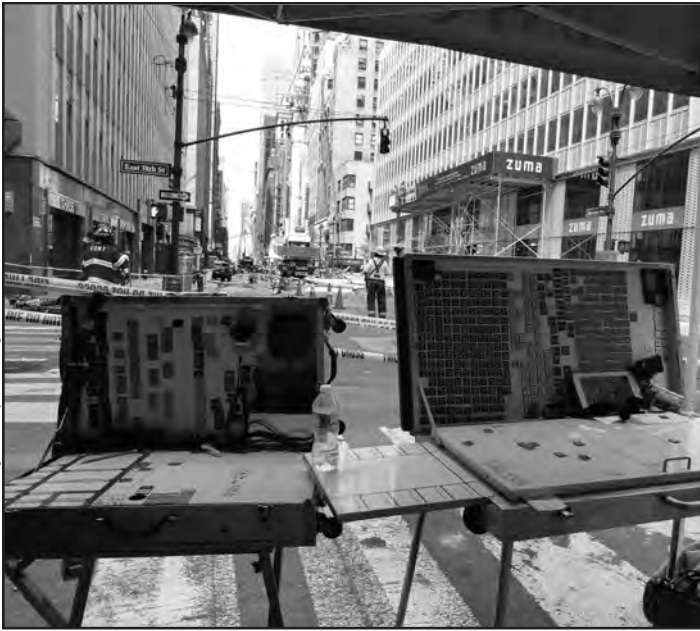
The Command Post was established on the southwest corner of Madison Avenue and East 38th Street, providing Chief Officers with good oversight of the incident.
