# Dump Truck Lands on Staten Island Pipeline

## FDNY Coordinates a Safe Conclusion

by Battalion Chief John A. Calderone

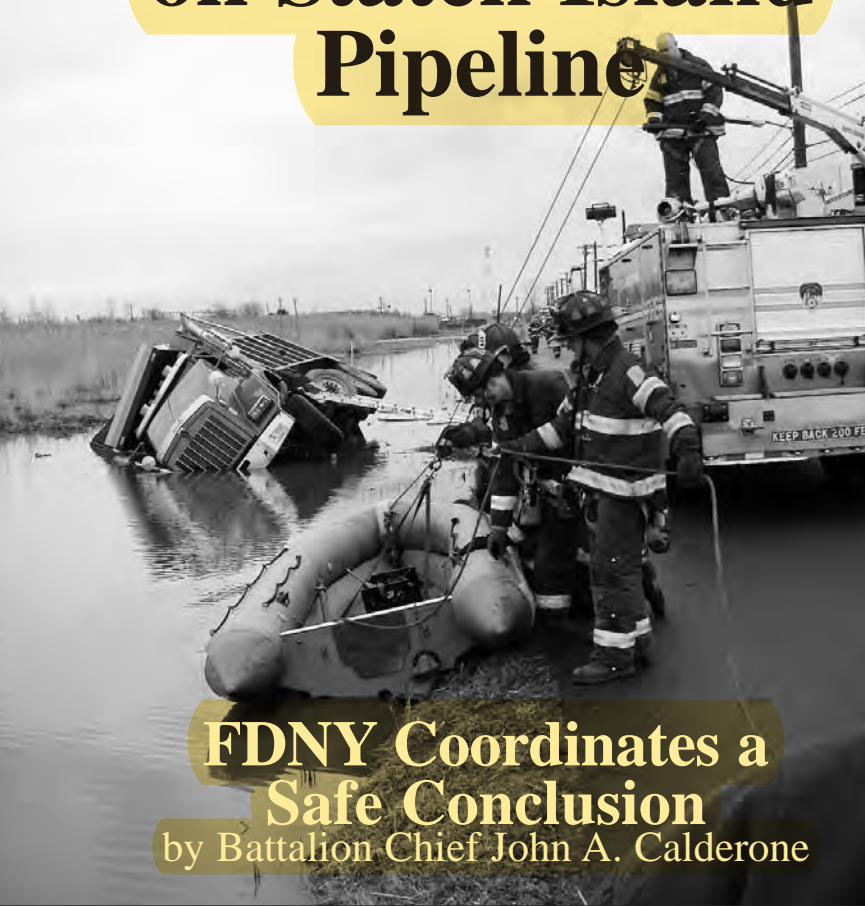
Initially, Engine 158 and Ladder 86 were dispatched. When these units arrived at 0805 hours, they immediately requested that Battalion 22 be assigned. At 0822 hours, Lieutenant Gary Van Pelt, Ladder 86, provided a preliminary report, indicating an overturned dump truck carrying contaminated soil was partially sub-

merged in a marsh and resting on a natural gas pipeline. Based on this report, Battalion Chief John Calderone, Battalion 22, while still responding, requested that Rescue 5, Haz-Mat 1 and Haz-Mat Engine 165 be assigned. The Rescue Battalion and Haz-Mat Battalion also were assigned at this time.

Arriving at the scene, Chief Calderone performed an initial size-up. The incident was located approximately 2500 feet south of the main plant entrance on Western Avenue. The truck, carrying a load of contaminated soil, was in the process of leaving the facility. Based on tire tracks, the right wheels of the dump truck had left the roadway and the truck traveled for approximately 100 feet, tilted on an angle, along an embankment before its left wheels left the roadway. It then entered the water, a moat adjacent to the main plant entrance road, and traveled approximately 50 feet before coming to rest on its side, with some of its load spilled into the water.
