Row Frames Revisited at Deadly Staten Island Five-Alarm Fire

by Battalion Chief John A. Calderone

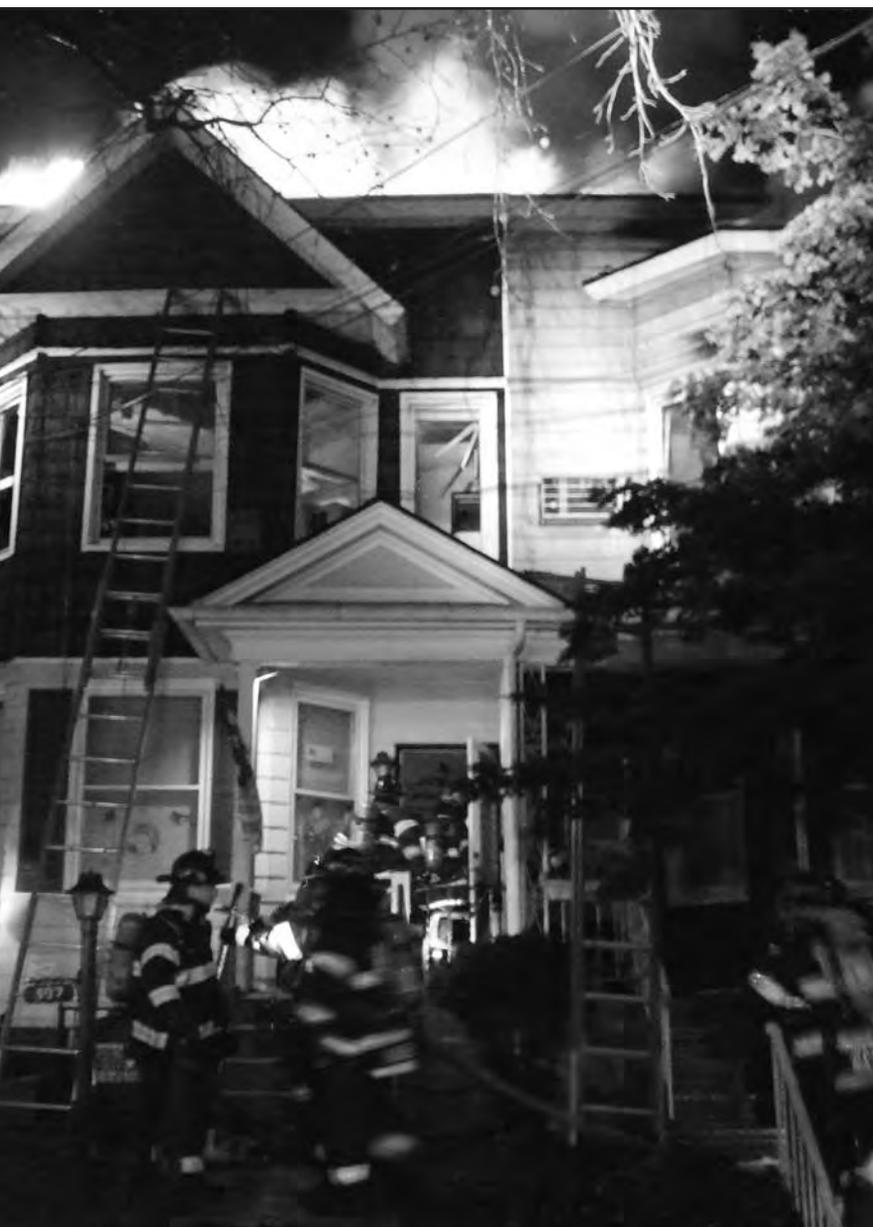
FDNY members operate at the front exterior of Staten Island Box 55-715, 401/403 Jewett Avenue/Post Avenue/Forest Avenue, January 10, 2009.
