FDNY Members Mitigate Another Andrew J. Barberi Ferry Crash

by Battalion Chief John A. Calderone

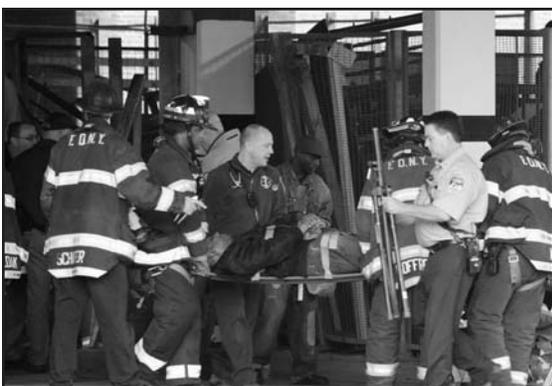
(Left) FDNY members move a victim away from the rubble. (Center) A tear in the side of the *Andrew J. Barberi* hull is revealed. (Right) Many FDNY units were committed to immobilizing patients and placing them on backboards. A victim is removed via stretcher to a waiting ambulance.
