The Twin Parks North West fire: Jan. 9, 2022

By Deputy Assistant Chief Frank Leeb

Twin Parks North West fire.

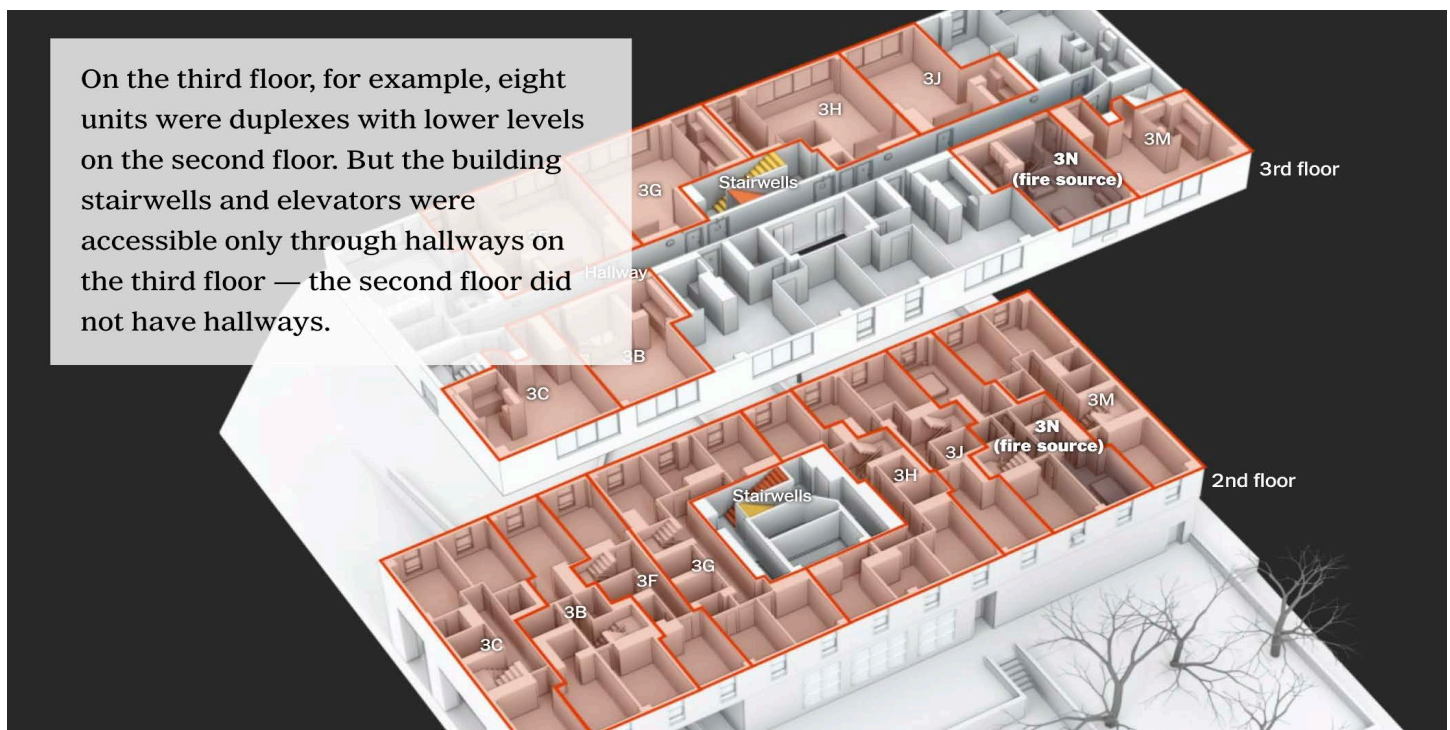
However, an integral part of the story was a chain of open doors that allowed

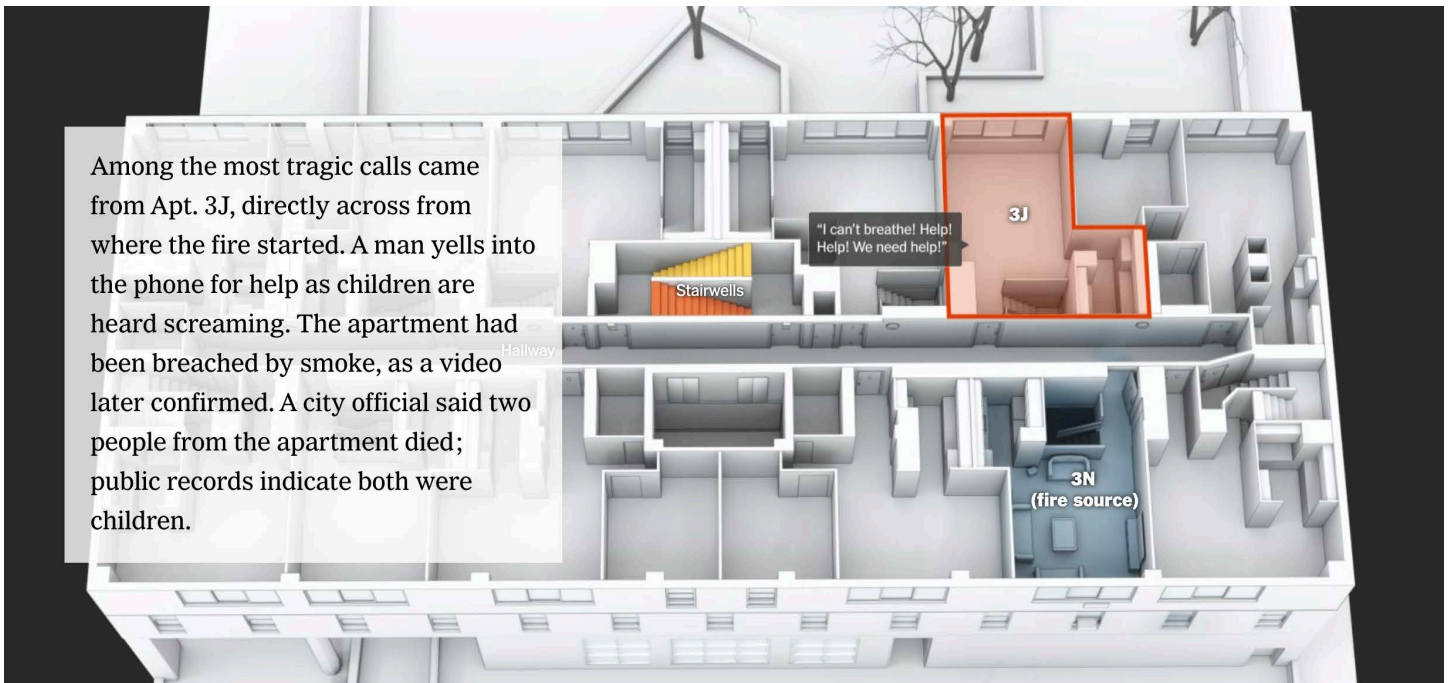
Among the most tragic calls came from Apt. 3J, directly across from where the fire started. A man yells into the phone for help as children are heard screaming. The apartment had been breached by smoke, as a video later confirmed. A city official said two people from the apartment died; public records indicate both were children.

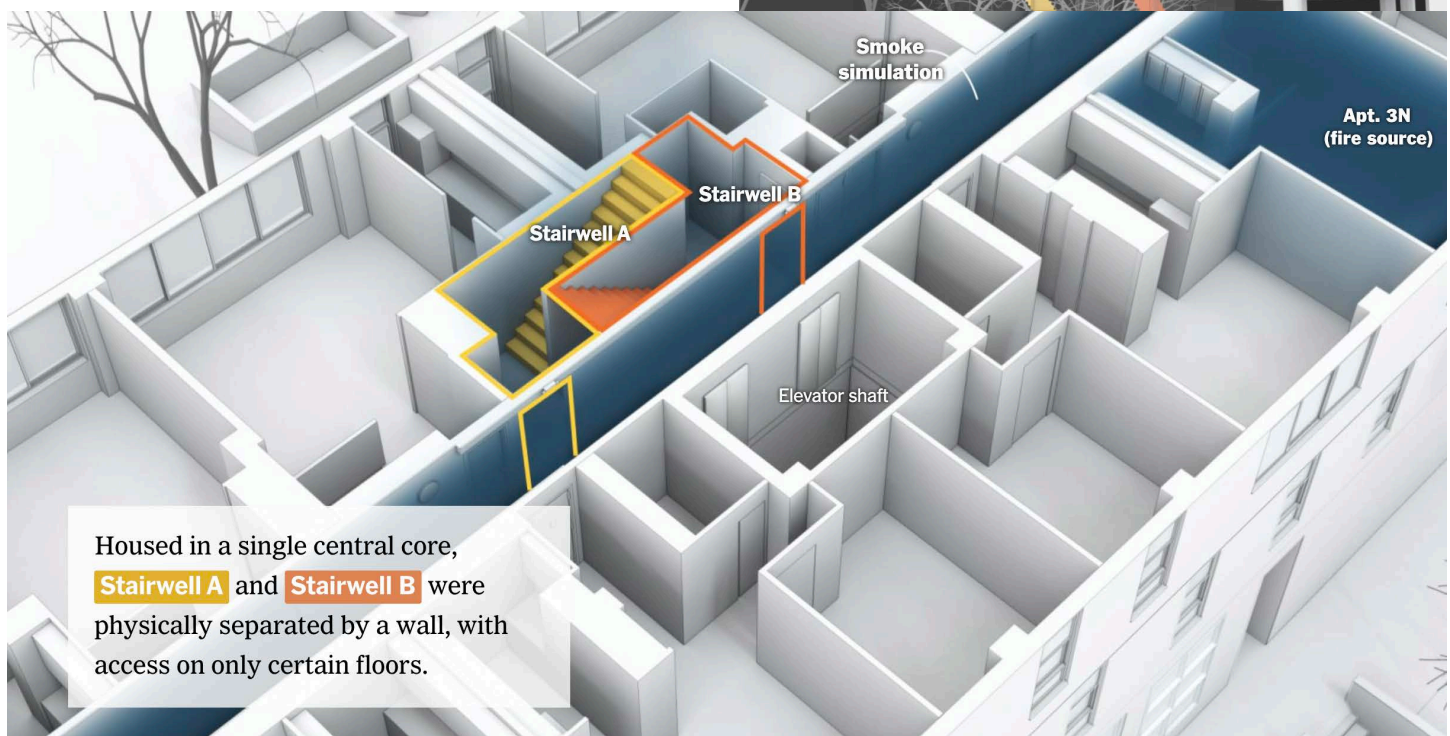
Housed in a single central core, **Stairwell A** and **Stairwell B** were physically separated by a wall, with access on only certain floors.

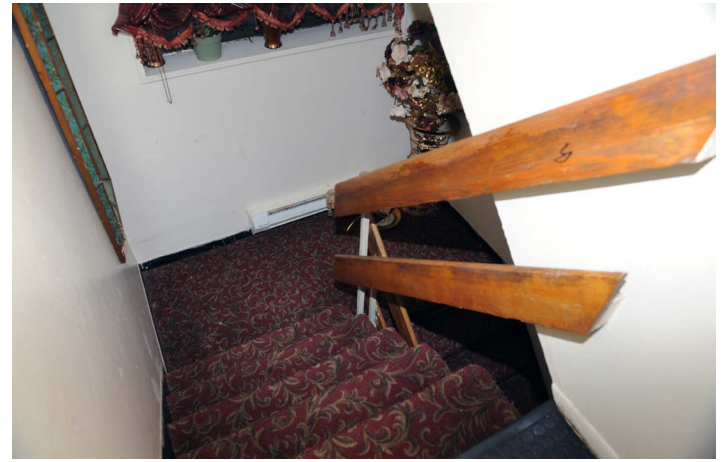
An exemplar photo of a “duplex-down” staircase in an unburned apartment, similar to the staircase in the fire apartment. (Photo credit: Bureau of Fire Investigation)

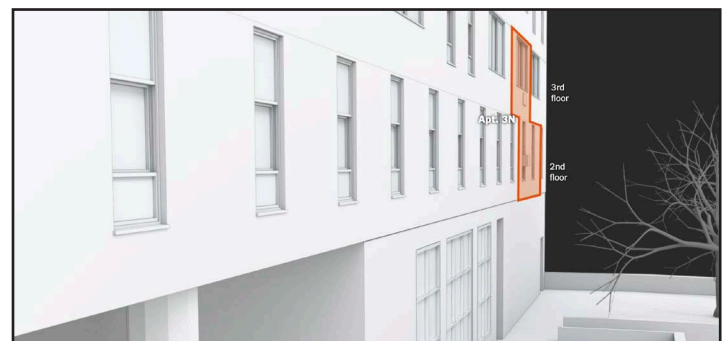
A review of other video showed flames coming out of Apt. 3N's upper level several minutes after appearing to have died down on the lower level, compounding the flow of smoke.

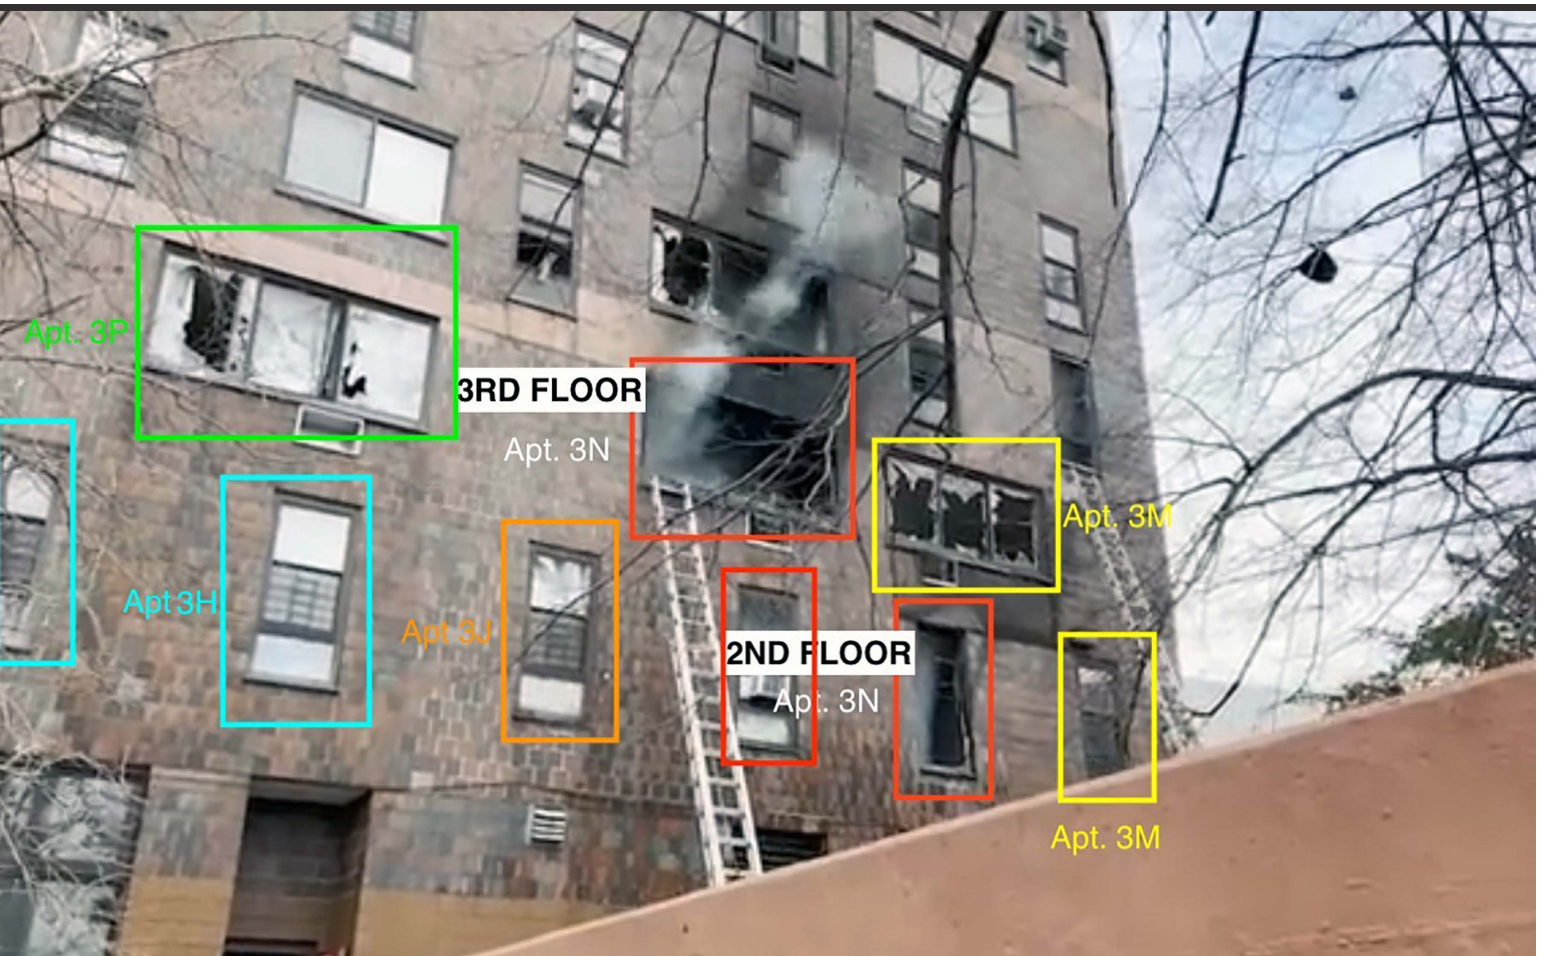
Diagram of the window layout on the exposure 3 side. Note that the (orange) window on the second floor is associated with Apt. 3J, which is accessible from an apartment door across the hallway (exposure 1) on the floor above (third floor), making it nearly impossible for firefighters on the exterior to identify the apartment layouts.
