Emergency... tank truck spill creates high hazard situation

by **ANDREW J. KERZNER**
Deputy Chief, 13th Division

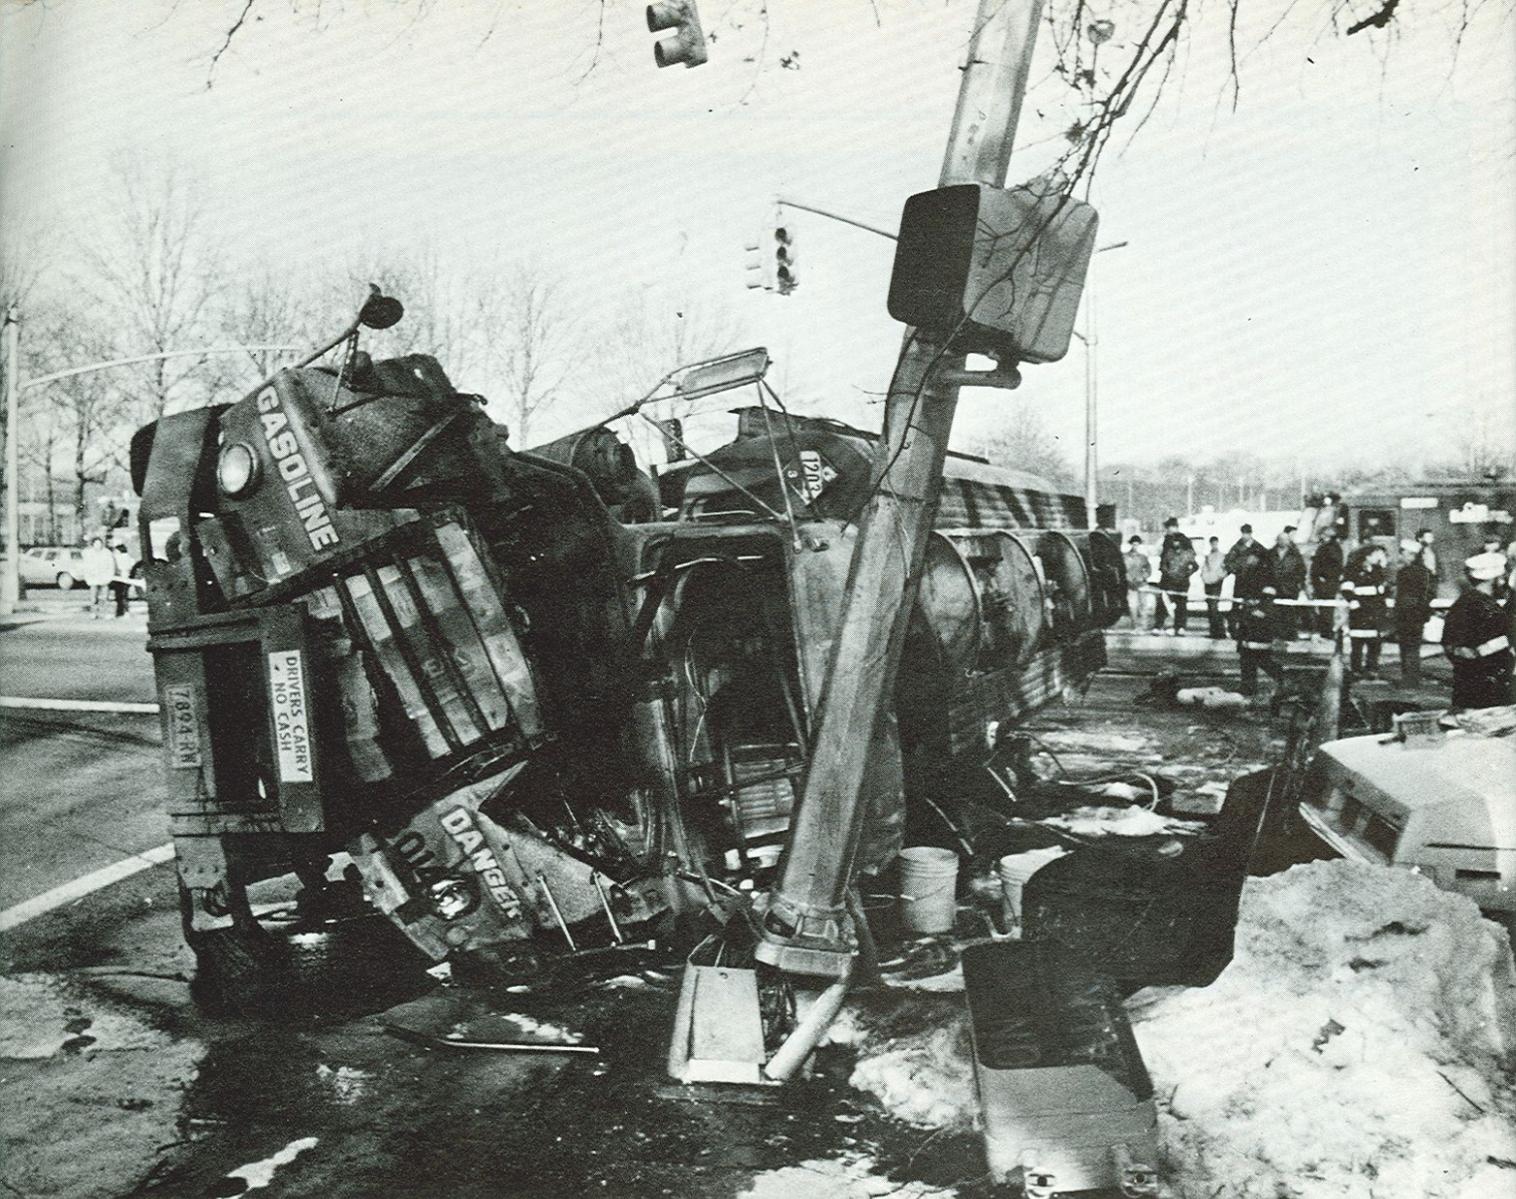
At about 1230 hours, at the intersection of Woodhaven Boulevard and Forest Park Drive, in the Borough of Queens, a tank truck, carrying over 3,000 gallons of gasoline, overturned. The tank truck, owned by the Island Transportation Company of Westbury, Long Island, N. Y., was lying on its left side, and was completely blocking three lanes of southbound Woodhaven

Boulevard traffic. The nose of the truck was resting against the traffic stanchion that it had knocked down at the southwest corner of the intersection.

First arriving units found gasoline flowing freely from one fully opened hatch cover, and leaking profusely from the other five, obviously sprung, closed hatch covers. The stunned driver was sitting on a park bench, and appeared to be in shock. The engine of his overturned truck was still running.

The fully opened hatch cover was closed, but it was apparent that none of the hatch covers were close-fitting in the overturned position, and gasoline continued to leak from all the hatches.

With a 2 $\frac{1}{2}$ " charged hoseline, and a 1 $\frac{3}{4}$ " foam line standing by, three members of Rescue Co. 4 worked in the spill area in order to seal the leaking hatches. A putty-like substance (trade marked *Plug and Dike*) proved successful in stopping the flow from five of the offending hatches. The remaining troublesome hatch was finally sealed by using special wedges and an improvised hose clamp.
