FDNY Safety and Health Issues at the World Trade Center Complex (Ground Zero)--Part II

by Deputy Assistant Chief Ronald Spadafora

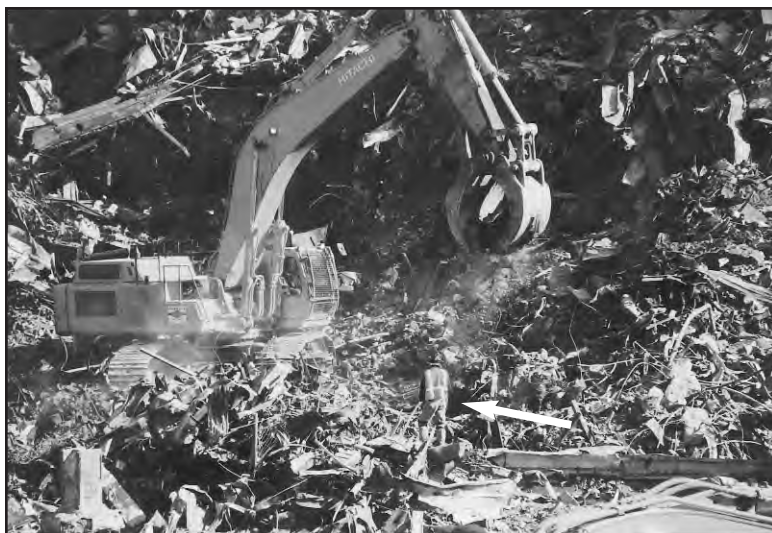
(Above) Lone spotter (debris removal observer) wore reflective vest (arrow) and stayed 50 feet from the operating radius of a demolition grapppler.

All Recovery Team personnel remained a minimum of 50 feet away from the operating radius of debris-removal equipment. Additionally, in areas of known instability (Restricted Work Zones) established by structural engineers, recovery operations were limited strictly to one spotter per machine.

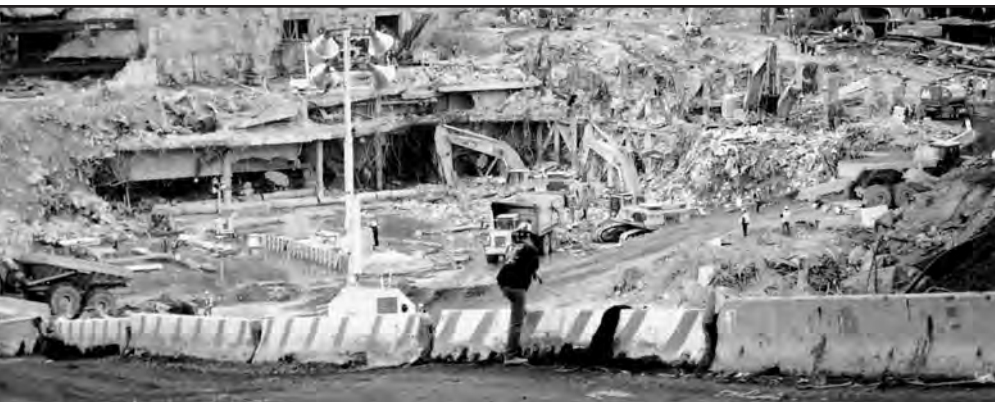
(Above) Fall protection--Jersey (cement) barricades along the Tully Roadway protected vehicle operators and recovery workers from fall injuries.

OSHA standards require workers to be protected from falls at elevations more than six feet above ground. The Site Safety Officer (SSO) often discussed fall hazards with the FDNY Operations Chief because conditions on the debris pile changed on an hourly basis. The placement of fall protection then was coordinated with the Prime Contractor Safety Representative responsible for the area.

Jersey (cement) barricades and wooden barriers were the primary systems used. When primary fall protection systems were impossible to install due to terrain, Chief Safety Officers identified fall hazards and instructed Recovery Team Leaders (Company Officers) to have members back away from exposed edges. Chief Safety Officers were authorized to suspend all operations if debris/rubble piles began to shift or falling debris from surrounding structures became a hazard.

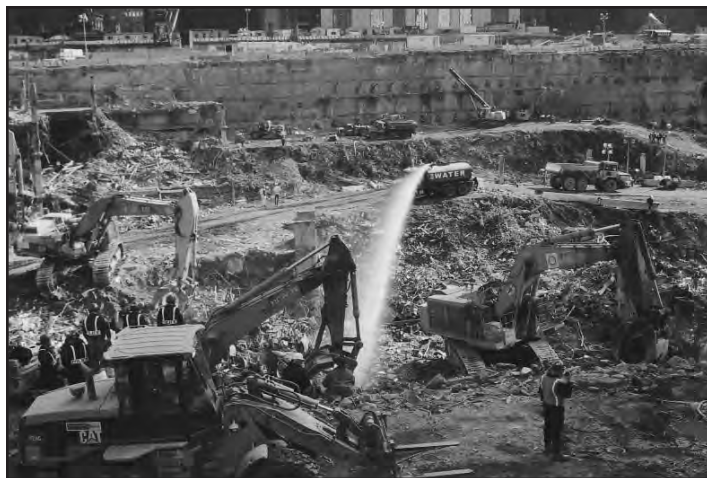
(Above) Dust suppression--Water tanker sprayed hot spot in debris field.

Many contaminants, including asbestos, metals, silica, organic compounds, aromatic hydrocarbons and others, were contained within the tremendous amount of debris and dust at Ground Zero. The prime contractors, employing water tankers for dust suppression on the debris pile, safeguarded workers and the surrounding community. The FDNY assisted in this operation with the use of tower ladder streams, multiversals, stangs and hand-lines. However, the primary focus was on extinguishing fires uncovered during the debris removal process.

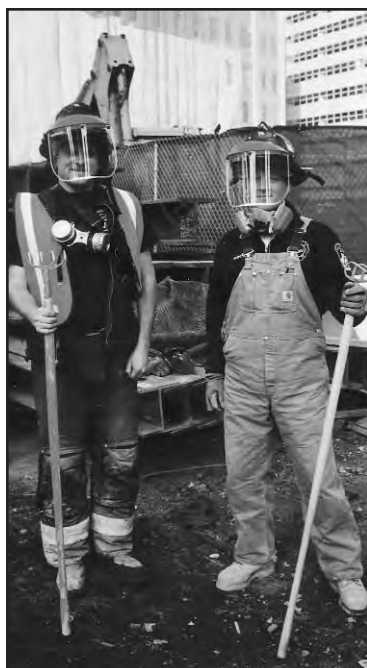
(Above) Full-face shield protection-- Firefighters sifted through debris containing ammunition.

WTC 6, Customs House, contained two pistol ranges (B-1 and B-6 sub-levels). Approximately one million rounds of live ammunition were stored inside these ranges. Ammunition consists of case material (brass or aluminum), lead projectile and the primer and propellant. Exposed to fire or temperatures above 392 degrees Fahrenheit, the primer and propellant can ignite, causing the case to fragment and act as a low-velocity projectile.

It is also possible to strike the primer to cause the ammunition to discharge. Steel-cutting in places where weapons, ammunition and explosives (small amounts used by PA police to train dogs) are located is strictly regulated. Recovery Team members examining the rubble in these selected areas were issued full-face shields for optimum eye protection. All discovered weapons were assumed to be loaded and FDNY members gave all explosives the hands-off treatment. Firefighters were instructed to evacuate the area a minimum of 100 feet in all directions and notify the PAPD or NYPD immediately through the FDNY chain of command.
