Fuel Oil Storage Tank Proves Deadly in the Bronx

by Battalion Chief Fred LaFemina

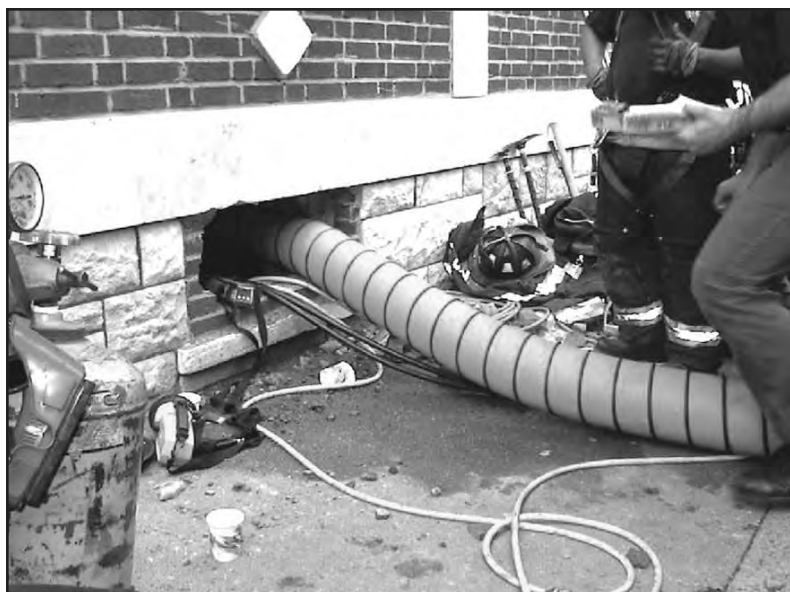
Units forced open a bricked-up cellar window to support the removal operation. Here, the ventilation duct and hydraulic hoses for the Stanley hydraulic blower, as well as electric lines and air monitor, are shown in the window opening.

Chiefs Callan, Dunne, Norman and LaFemina and Lieutenant Citarella conferred at the Command Post to determine the method of removing the victims. To provide fresh air to the area, the basement was vented by removing bricks from window openings that had been covered over and exhaust fans were placed at the openings to assist in removal of contaminants that might be present. This provided fresh air to the area and allowed FDNY members to work safely.

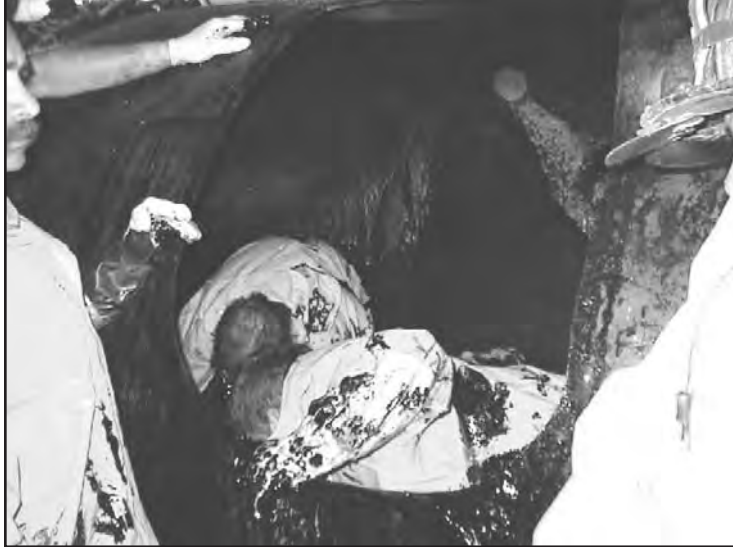
FFs John O'Connell (left) and Michael Davis of Rescue Company 3 prepare to remove the first of the overcome workers after entering the tank through an opening that had been created with a sawzall. Note use of disposable PVC Level D suits instead of bunker gear. The heavy #4 oil necessitated that any contaminated clothing be disposed. Flash point of this oil is 125 degrees.

With a great degree of difficulty--since both bodies were immersed in the fuel oil--Firefighters O'Connell and Davis entered the tank and removed the two victims. The bodies were removed to the court area on the exposure #2 side of the building. This allowed the Police Department Crime Scene Unit to conduct their operation. When the Crime Scene Unit completed their work, the medical examiner requested both victims be decontaminated prior to removal, since they were both covered in fuel oil. Chief Dunne special-called Squad 61 to assist Haz-Mat 1 with the de-con of both victims, as well as FDNY personnel. The SOC Decontamination unit also was special-called to assist with decontamination and provide Companies with loaner gear for members whose bunker gear was contaminated with fuel oil.

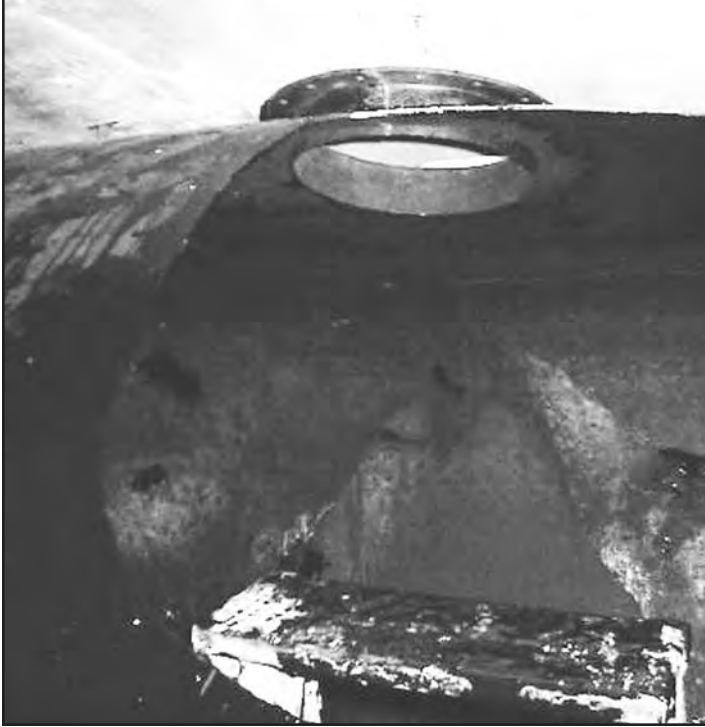
A view through the rescuer's access, showing the 16-inch-diameter manhole the workers used to enter.

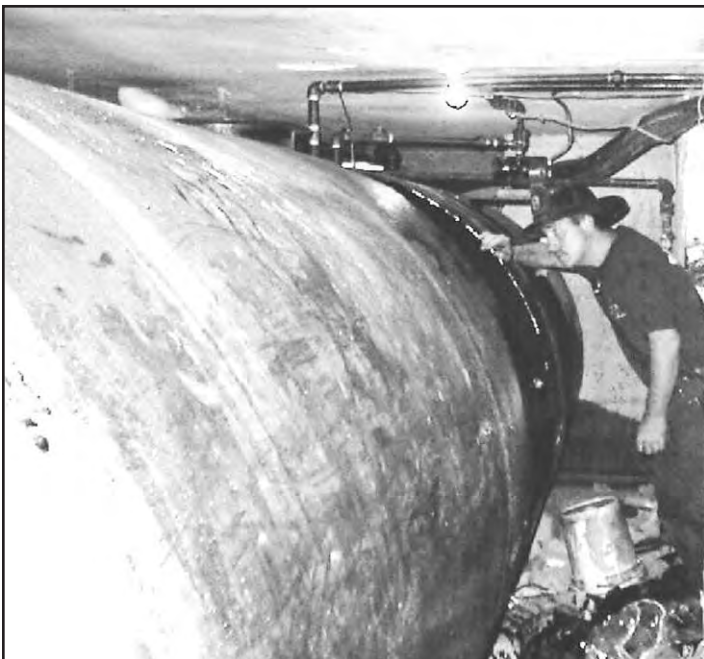
A view down the length of the 4000-gallon tank shows a rescuer surveying the scene. Note the minimal clearance (12 inches) between the concrete cellar ceiling and the lip of the manway the workers used to enter.

The alternate plan involved removing the workers through the top of the opening in the tank. It would be accomplished via the first-floor level of the building. This would be a slow and difficult operation because of the height limitations between the top of the tank and the ceiling above, the time it would take to break through the concrete basement ceiling and the condition of the bodies.
