SOC Operations at Brooklyn Helicopter Crash

by Battalion Chief Fred LaFemina

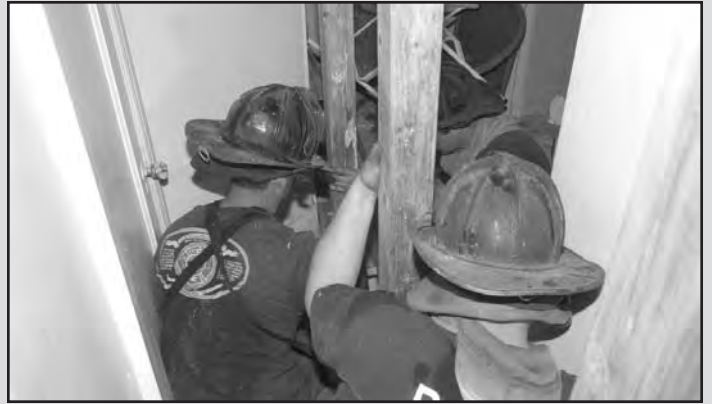
The shoring systems installed were a critical component to the overall success of this operation.

The shoring systems to be installed had to support the weight of the helicopter to prevent it from collapsing the entire roof to the floors below. Vertical shores were placed directly below on the top floor, on the first floor and the basement area as well. While this may seem like overkill, it assured that the load would be supported properly and then evenly distributed. Dangerous operations continued on the roof area for many hours and the shoring that was installed created a solid foundation for the working members.

A shoring station was set up outside the collapse zone and supervised by Lieutenant Bob Chiusano, Squad 252. His members and Ladder 132 performed all the cutting and delivery of the lumber to build the shoring systems. Eight vertical shoring systems were installed, including three in the top-floor apartment. Rescue 2 conducted this operation, assisted by Squad 252.

The last two shoring systems were installed by Rescue 2 in the basement area. They were located directly in line with the shoring systems installed on the two floors above. After all eight shoring systems were installed, the building was stable and safe for FDNY members to conduct the rest of the operations. The shoring also provided a safe work area for NYPD, as well as the National Transportation Safety Board (NTSB), both of whose members conducted investigations.
