# Safety Concerns at Confined Space Operations

by Battalion Chief Eugene Vellia

On the arrival of Battalion Chief Eugene Vellia, Safety Battalion, confined space operations already had commenced by the first-arriving units. As the Safety Officer at Brooklyn Box 0068, 301 Greenpoint/Kingsland Avenues, September 24, 2008, Chief Vellia had to assess the potential hazards associated with a confined space incident in a large, enclosed concrete tank. The following information pinpoints the conditions during the operations with which Safety was concerned.

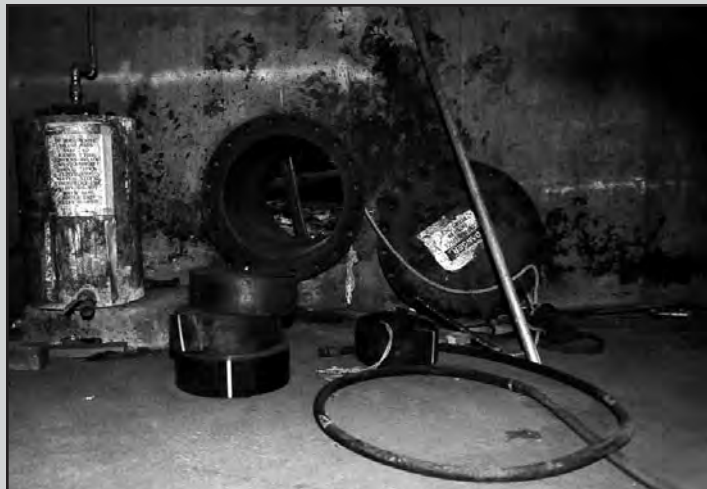
Base of the tank and the porthole within the building. The victim was partially within this porthole and exited here. Exterior tank operations took place at this location.
