Collapse Units

by Battalion Chief John A. Calderone

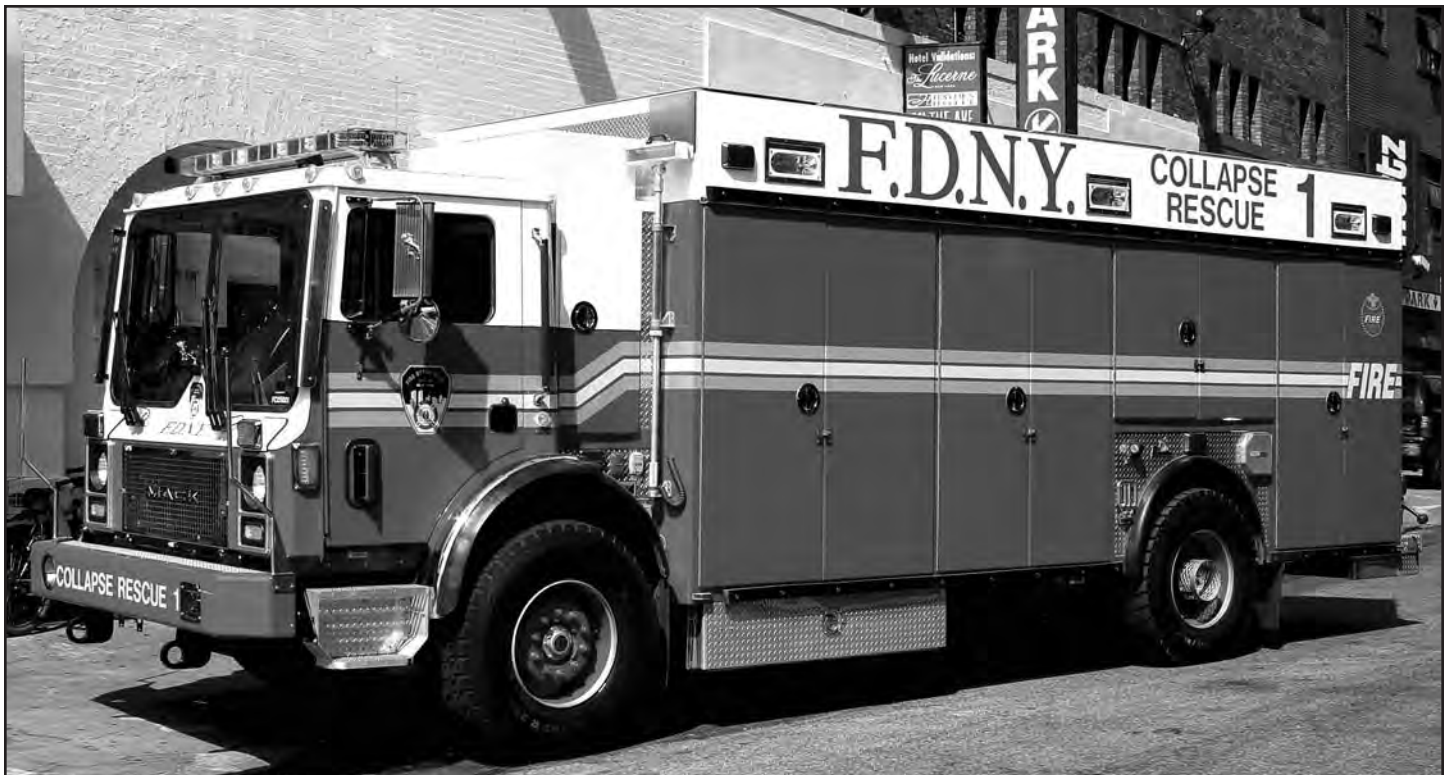
One of three new collapse rescue vehicles that are assigned to Collapse Rescues 1, 2 and 4. Collapse Rescue 5 operates a similar, but older apparatus.

During July 2005, three new collapse apparatus, built by Ferrara on Mack chassis, were placed into service as Collapse Rescues 1, 2 and 4. The 1991 Mack at Collapse Rescue 1 was reassigned as Collapse Rescue 5. This provides each borough with its own collapse apparatus and allows the Department to create five Collapse Rescue Task Forces consisting of a rescue company and a collapse rescue apparatus.

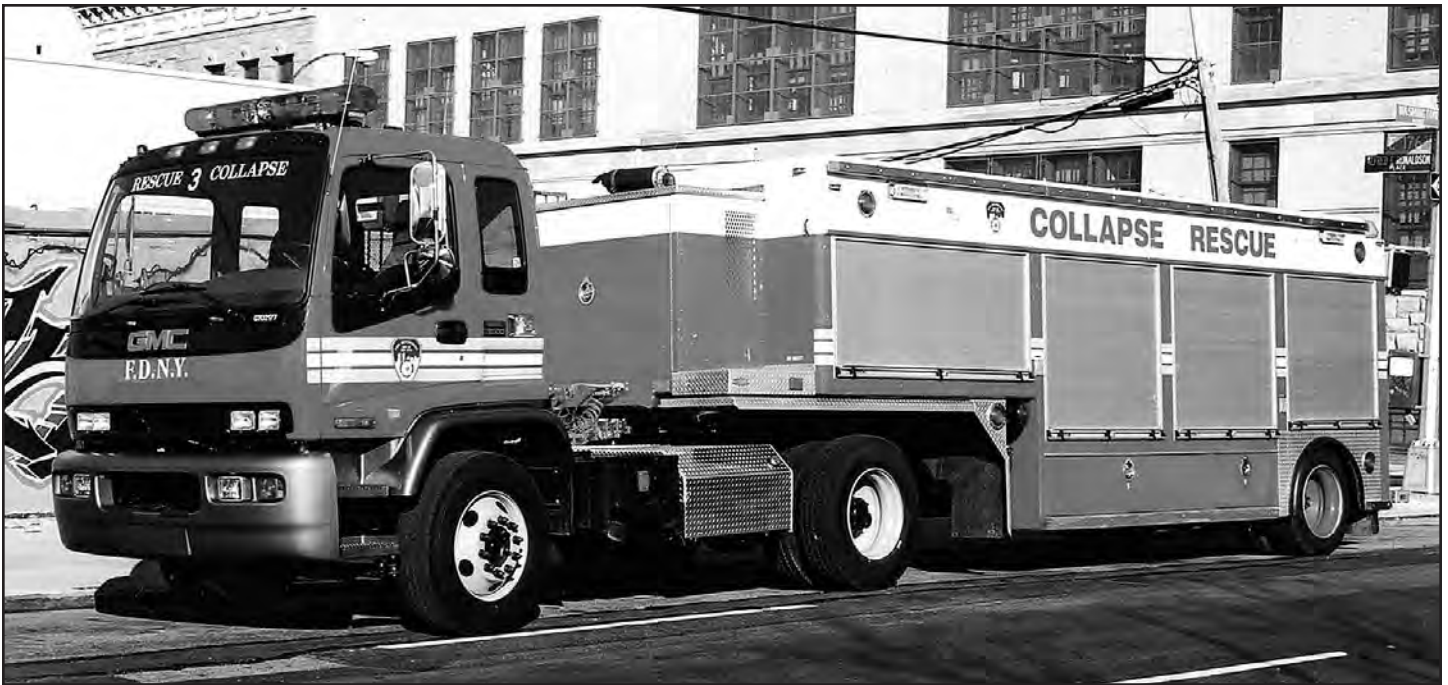
Collapse Rescue 3 operates this tractor-drawn collapse rescue apparatus.

Collapse Rescue 1 is located with Ladder 25. Ladder 14 is its back-up unit. Collapse Rescue 2 is quartered with Ladder 132, while Ladder 131 is its back-up unit. Collapse Rescue 3, now operating with a 2002 GMC tractor that replaced its original Ford tractor, is quartered with Rescue 3. This is the only Collapse Rescue apparatus that is a tractor-trailer.

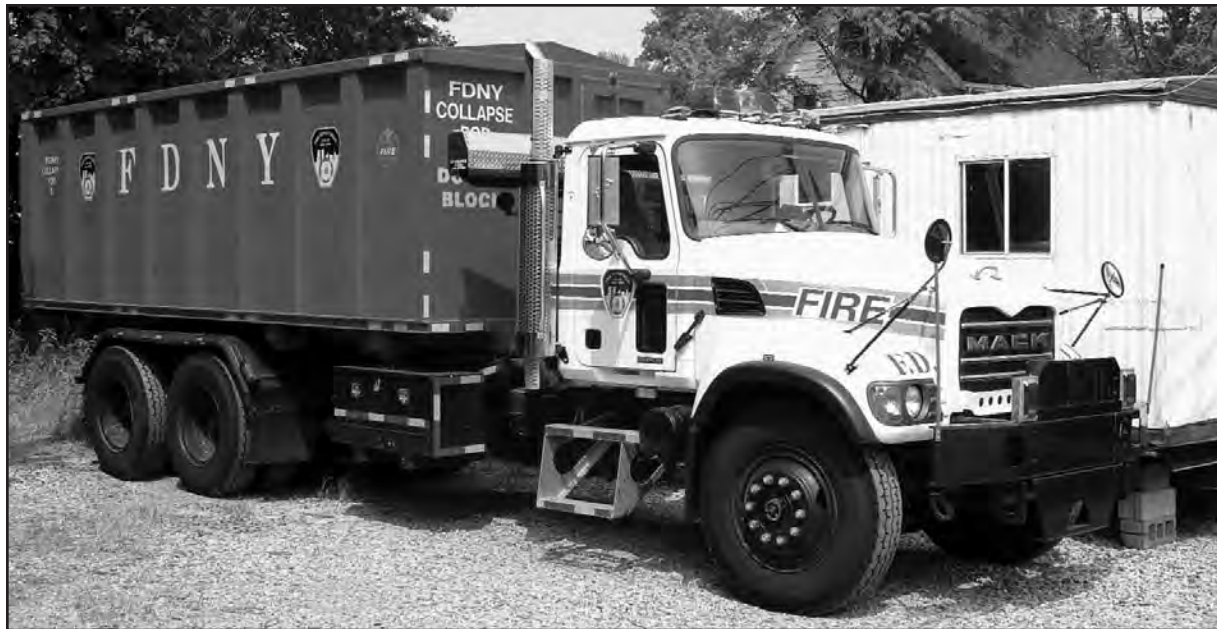
Two roll-off trucks have entered service to transport 10 collapse pods that are pre-positioned throughout the City.

To further enhance collapse capabilities, the Department has purchased 10 collapse pods, which have been stocked with shoring, metal and concrete-cutting saw blades and a cutting table with templates for fabricating shoring. These containers are dispersed at Department facilities throughout the City, with two containers in each borough.

To transport these containers, two 2004 Mack roll-off trucks have been placed into service. Engine companies have been trained to operate these vehicles. Roll-Off 1 is located at the Fire Academy. Engine 91 is the primary delivery unit, with Engine 60 as the back-up unit. Roll-Off 5 is located at the quarters of Ladder 79. Engine 156 is its primary delivery unit, while Engine 154 is its back-up unit. These pods are not intended for use during routine
