# Response to Refrigerant Leaks Case Study: Queens Library, Langston Hughes Branch

By Lieutenant John C. Berna

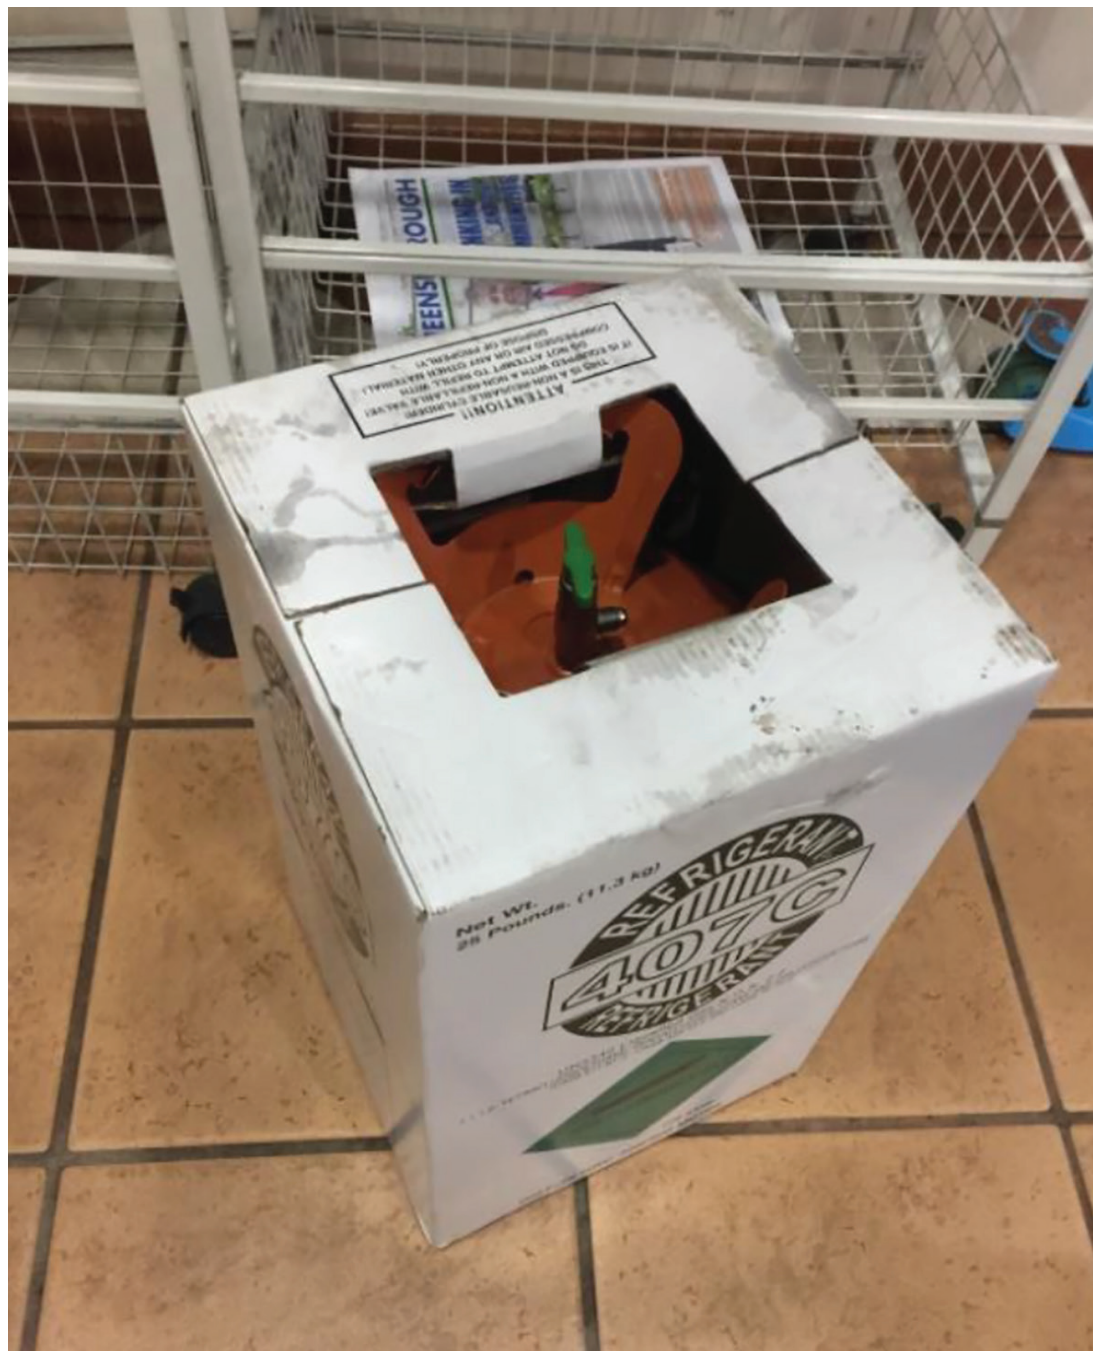
Photo 1—Container taken from basement to confirm refrigerant.

Refrigerants usually are stored in cylinders/tanks; the cylinder is dependent on the specific refrigerant. The most common cylinder used by those in the refrigeration industry is the 20- or 30-lb., one-time use, low-pressure tank. These cylinders are similar in looks to a propane barbecue tank. They are short, with a rounded top and provided with a handhold. They have a rounded bottom and

usually contain three protruding dimples to keep the rounded tank level when sitting in the ground (Photo 1). Freons and SUVAs (a DuPont trademarked chemical of hydrofluorocarbons) are stored in these tanks and used on smaller refrigeration units. An advantage to this type of cylinder is that there is abundant information printed on the cylinder itself. On the roadways, you will find refrigerants shipped by tractor trailers, intermodals and via rail. Small amounts used to recharge automobile air-conditioning units are found in 13-oz. cans.

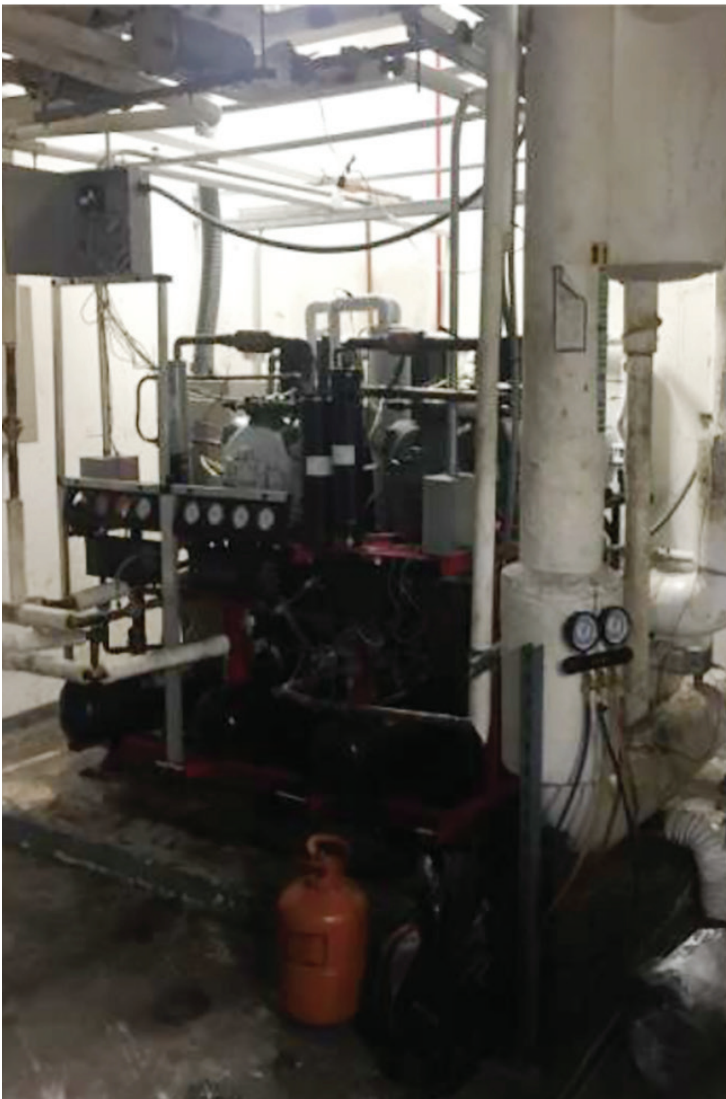
Photo 2—Large air-conditioning system located in the basement of the library.
